Repairing a Rover SD1 Vitesse LT77 Manual Gearbox Speed Transducer

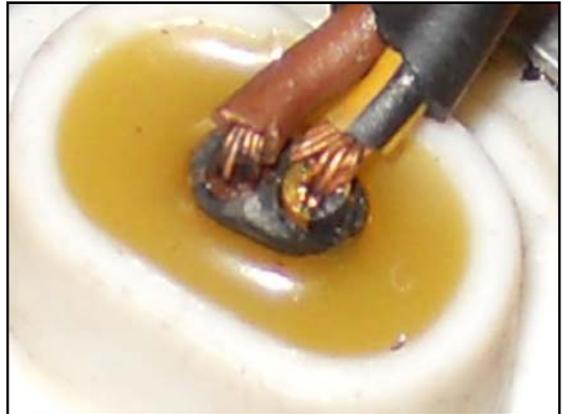
Neither were there any visible broken wires but as seen in the first image, a result of Rover SD1 LT77 Manual Gearbox Speed Transducer cable being exposed to 18 years of excess heat radiated by a close proximity twin after-market stainless steel exhaust pipe (plus any local flexing), the cable insulations have shrunk significantly. This may have allowed one of the soldered joints inside the epoxy filler to become seriously compromised (dry), intermittently affecting 3 major instrumentation functions, Speedometer, Trip Computer and Cruise Control. The original single exhaust pipe's position in the transmission tunnel would be less likely to cause such a problem.

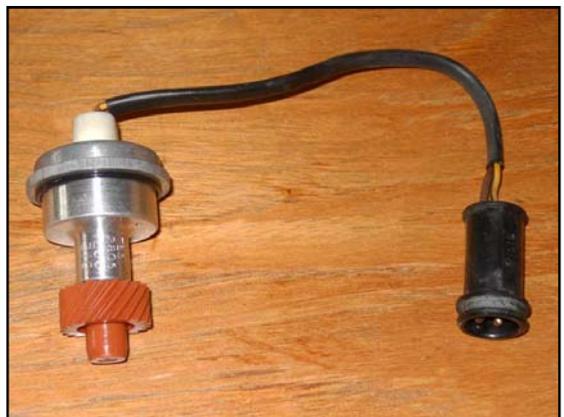
The first thing to do was to snip off the two wires, but not before noting their exact relationship to the body of the transducer as seen in the second image.

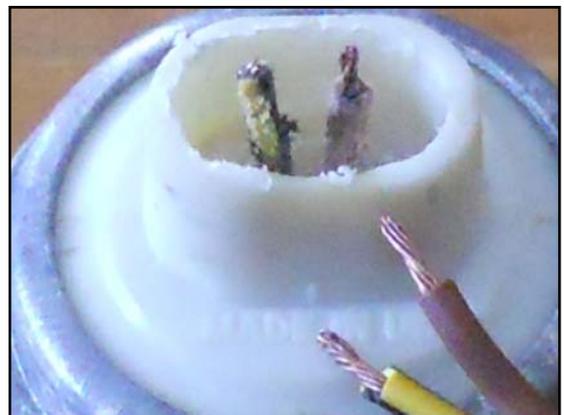
So, with flexing a distinct possibility, a more common Speed Transducer failure mode is where a wire simply breaks, in which case the fault becomes permanent as opposed to intermittent. Alternatively it's possible that the connections seen in the image were intermittently shorting to each other, but measurements at the speedometer did not indicate that to be the case. There was no a hard 12volt signal that would have come from the yellow/black wire if it were shorting out to the brown wire.

Such 'hard' failures are usually easier to see and/or diagnose, however with the case in hand, the output signal on the brown wire was simply disappearing, randomly. The logical deduction was therefore, the damaged insulation had caused a failed local soldered joint below the epoxy filler.

A razor saw is the ideal tool to neatly cut away part of the plastic housing clearing the area for access to remove all traces of the original insulation and allow plenty of room to tin the wire stubs using a good quality flux prior to re-soldering the leads to the stubs as seen in the next image.
