## Engine Idling Problems on Rover SD1 Vitesse with Twin Throttle Plenum

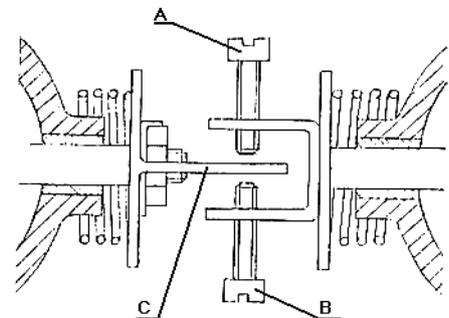
### Check that the front throttle closes fully

A common fault on this mechanism is “Idle Speed Hang-up”. Friction anywhere in the assembly is the killing factor caused variously by damage, misalignment, contamination and maladjustment. Blocked airways and air leaks are also a concern. This action program will resolve the problem.

- Warning: Throttles must never be moved by turning the interconnecting joint, as this will cause the rear spindle to distort or break.
- If necessary, adjust the two screws on the interconnecting joint as follows:
- Turn screw “A” until there is a gap between it and lever “C” of about 3 mm. Repeat with screw “B”.
- Turn screw “A” until it is about to, but does not quite touch lever “C”. Repeat with screw “B”.

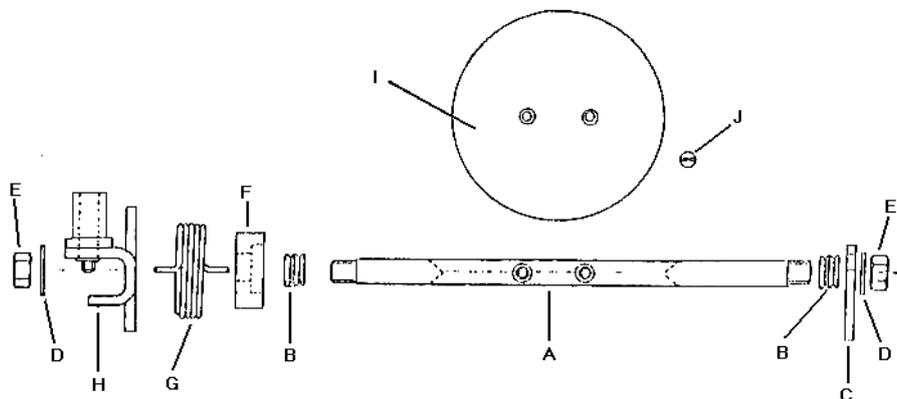
### Rear Throttle Assembly

- The quadrant to jackshaft fit is carefully adjusted during manufacture and would not normally be disturbed, except, as most systems were manufactured more than 20 years ago, incorrect fit due to worn parts is now quite common. The following actions can be taken.
- Disconnect the throttle cable from the quadrant and remove the return spring.
- Undo the quadrant securing set-screw/nut/washers and remove the quadrant from the shaft.
- Check the hub area of quadrant for distortion and undue wear preventing it from securely gripping the jackshaft. If damaged, it would normally be discarded and a new one fitted.
- New items may be difficult to obtain but it is possible for the quadrant hub to be dressed and adjusted to restore its grip. This requires careful use of a small hacksaw to open the hub slot and a small file to reshape the seats for the securing set-screw, nut and washers.

- Check the jackshaft for scoring. Use fine emery paper to smooth off any wear and refit the quadrant, ensuring secure attachment of both items to the throttle bracket.
- Adjust the quadrant on the jackshaft so that the rear throttle just begins to open as the quadrant moves away from the stop.
- If after the above actions the engine idling speed is still excessive, it may be necessary to remove the plenum chamber to check the following:
