A Flat Solution to a Lumpy Problem with the Rover SD1 Binnacle Cover.

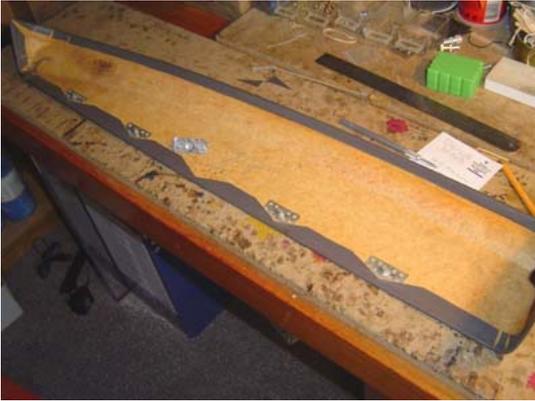
If, like me, you have purchased a new binnacle cover for your SD1 from Rimmer's ex-India stock then you will very likely be pleased with the change in profile from lumpy to smooth on top of the instrument housing. However, it might not stay that way when the interior climate of your SD1 gets to work on the compressed cardboard and in a few months, at worst, or a few years at best, you will once again see the old familiar profile. Well, you can do something about it and delay the day when the inevitable happens.

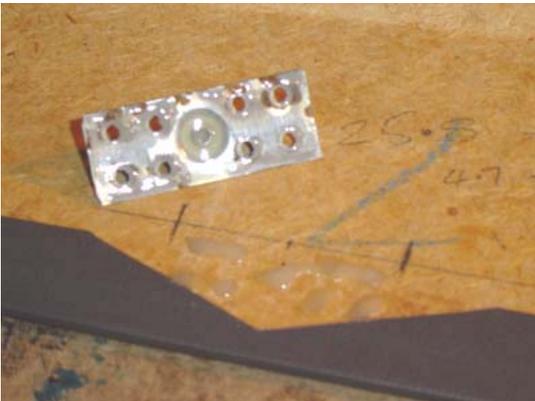
The reason, apart from climate, is nearly all the original covers and all the ex-India items have just four buttons to attach them to the top of the instrument housing. Yet, amazingly, the housing has five buttonholes. Have a look at your housing and see the extra fixing hole, dead centre between the four existing locations. What is needed is to fit a fifth button, dead centre, to the cover.

From your discarded cover carefully remove a button/fixing plate from the underside. Using a file or bench grinder, smooth off the rear face where it has been punched through to form eight attaching claws for the original moulding process. Now carefully mark the exact centre position for the fifth button on the new cover. Place the button plate in position and mark through the holes with a soft pencil or fibre tip marker.

Next, use a small drill/router in a "dremel" type drill to broach out eight blind/shallow holes at the marked positions. Be very careful not to drill through the cover. These holes only need to be about 1/16" deep, sufficient to provide a good key for the adhesive.
