## Things for a Boy (or Girl) to do with his (Rover SD1) Blanket.

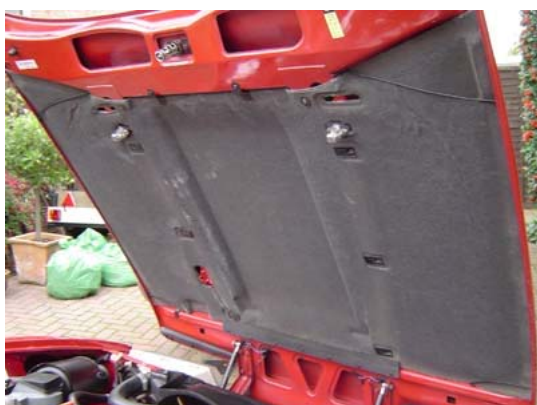
It was a forgone conclusion to buy a new under-bonnet blanket for my TP Vitesse (even if a little pricey) from Rimmer's ex-India stock. Problems with the old one were legion. For a start-off it had shrunk (they all do) and had long since failed to tuck into the folded edges of the bonnet. Then the corners started to hang down (they all do). Then the flapping edges/corners were stuck in place with evostick (nearly everybody had to). Then it started to disintegrate (hands up who's did not?). Then some retaining devices were devised to keep the damn thing tidy (not many owners did this).

Several splendid reasons to capitalise on the availability of new stock so a good one was selected at the September 2006 Spares Day (some were a bit ropey). After removing the old one, a few layers and types of sticky stuff and backing paper, amalgamated to the surface, were revealed. What a mess? Never mind, it would not be seen at all with a new blanket fitted, so most of the lumps, bumps and loose crud were washed and scraped away and the rest generally smoothed off with a stiff brush. Waxoyl was then applied to the area due to be covered by the new item, and let dry.

Offered up, the replacement would clearly fit exactly as Rover intended and is well supported by its six retaining clips with the sides neatly tucked into the bonnet edges. Yet, in our increasingly humid climate, for how long one wonders? Hence, to combat future shrinkage the former retaining gadgets are duly tidied up and re-fitted. The images show these fixings and their location.

Two central stepped brackets are fixed with self tapping screws and spring retaining nuts behind the stiffener panel, using existing holes. Two penny washers are retained by self tapping screws in small holes drilled at the locations. Four corner retaining bands are fabricated from substantial plastic-covered garden wire with a rolled end to push into the edge and a hook at the other end tensioned into existing holes in the panels. They are a bit of a fiddle to make but are effective when fitted. Mine just need a bit more black paint to tidy them up.
