Things for a Boy (or Girl) to do with his (Rover SD1) Blanket.

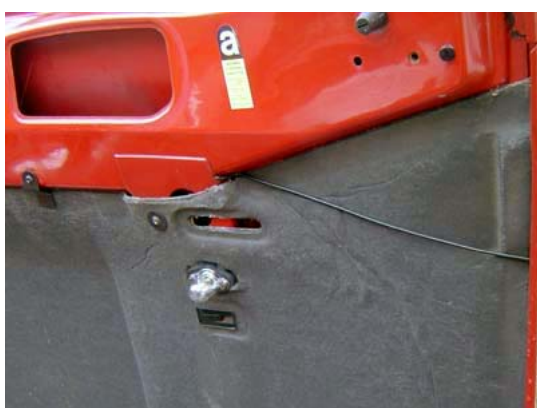
Several splendid reasons to capitalise on the availability of new stock so a good one was selected at the September 2006 Spares Day (some were a bit ropey). After removing the old one, a few layers and types of sticky stuff and backing paper, amalgamated to the surface, were revealed. What a mess? Never mind, it would not be seen at all with a new blanket fitted, so most of the lumps, bumps and loose crud were washed and scraped away and the rest generally smoothed off with a stiff brush. Waxoyl was then applied to the area due to be covered by the new item, and let dry.

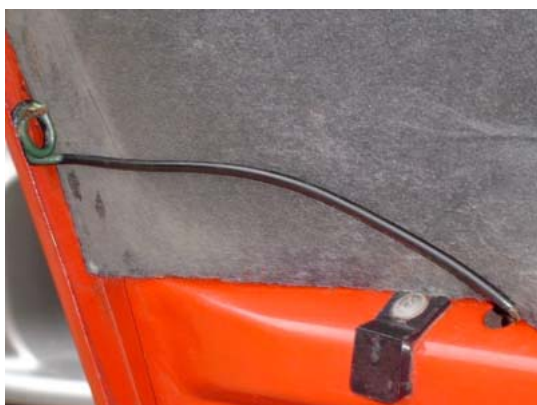
Offered up, the replacement would clearly fit exactly as Rover intended and is well supported by its six retaining clips with the sides neatly tucked into the bonnet edges. Yet, in our increasingly humid climate, for how long one wonders? Hence, to combat future shrinkage the former retaining gadgets are duly tidied up and re-fitted. The images show these fixings and their location.

Two central stepped brackets are fixed with self tapping screws and spring retaining nuts behind the stiffener panel, using existing holes. Two penny washers are retained by self tapping screws in small holes drilled at the locations. Four corner retaining bands are fabricated from substantial plastic-covered garden wire with a rolled end to push into the edge and a hook at the other end tensioned into existing holes in the panels. They are a bit of a fiddle to make but are effective when fitted. Mine just need a bit more black paint to tidy them up.

Finally the engine bay was treated to a new set of under-bonnet lamp-holders and wiring (which have been kicking around the workshop for yonks), a new pair of buffers screwed into the holes seen top-right in the second image, a new air intake grill and a new bonnet retaining bracket/clasp at the centre of the air intake area to replace the one that looked quite battered after years of inaccurate bonnet closing.
