Rover SD1 V8 Electronic Ignition System - Locating Intermittent Faults

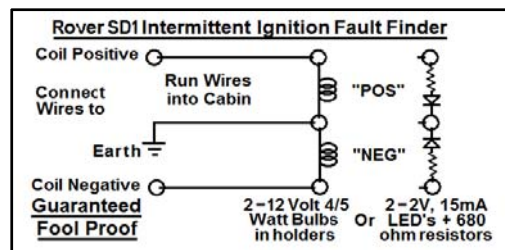
- Connect two 12V 4/5W bulbs (or 2V 15mA LED's + 680ohm resistors) linked between coil + ve and coil - ve to earth.
- Mark the lamps "POS" and "NEG" and route the wires safely to the cabin.

- Keep them clear of hot/moving parts.
- Start the engine and observe that "POS", sensing the ignition input voltage is permanently on.
- Observe "NEG", sensing the pulsed voltage across the ignition amplifier flickers in sympathy with engine rpm, or is dimly lit (LED's flicker better).

- Or, a short on the same circuit due to burned insulation.
- If "NEG" comes on full, the amplifier or its associated wiring/earth contact has failed in open circuit mode.

- Or, the pulsed input from the pick-up coil to the amplifier from the dizzy has failed.
- Or, the associated wiring is faulty/shorting to earth.
- Or (unlikely) the coil has failed in a short circuit mode.

- If "NEG" goes out, the amplifier has temporarily failed in short circuit mode due to excess internal heat or the local wiring is shorting to earth.
- Or, the coil failed in open circuit mode due to insulation breakdown or internal heat.

- If "POS" stays lit and "NEG" show signs of flickering instability, not sympathetic with engine rpm, then the amplifier or its connections are on the blink.

- If neither "POS" nor "NEG" change behaviour the fault is not in the primary side.
- Attention now reverts to secondary side HT components or the fuel supply system.
